CASE REPORT Open Access

Endovascular treatment of arteriovenous graft dysfunction as a result of graft delamination and fracture

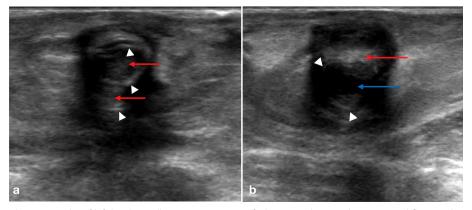
Fig. 1 a, b Doppler ultrasonography of left brachio-axillary arteriovenous graft showing echogenic linear material floating distinctly within the graft lumen (blue arrow), suggestive of delaminated graft fabric layers (arrowheads). It also shows thrombus in the false lumen created by graft delamination and an intraluminal thrombus (red arrows) (a)

In patients with arteriovenous grafts, any process which disrupts the luminal surface of the graft such as hemodialysis needle cannulation, insertion of vascular sheaths for endovascular intervention or angioplasty or rotational thrombectomy can create a plane between the layers of the graft which allows the blood to enter the false lumen and result in further delamination of the graft material. Alternatively, there can also be delamination of the pseudointima, which is formed by a complex matrix of cells and fibroblasts over the graft luminal surface, and this can create a false lumen (Roy-Chaudhury et al. 2001). A manufacturing defect in the layer adherence or apposition can also predispose a graft to delamination in the future. In this case, the patient's Gore Acuseal graft (Gore Medical; Newark, DE) is comprised of three layers (an abluminal ePTFE layer, an elastomeric layer, and a luminal heparincoated ePTFE layer), which may have got separated causing the delamination, likely from repeated puncturing at the same spot during dialysis access from 17G needle.

Management of graft delamination differs from that of conventional stenosis as delamination cannot be corrected by conventional angioplasty and thrombectomy, which are typically used to salvage the AV grafts. In these patients, stent-grafts are needed to cover the area of delamination to open the true lumen and prevent the flow of blood into the false lumen. This can then be confirmed by improved flow visualization, physical examination and angiographic appearance. The recognition of this phenomenon is essential to provide quality care and successful reuse of the AV graft.

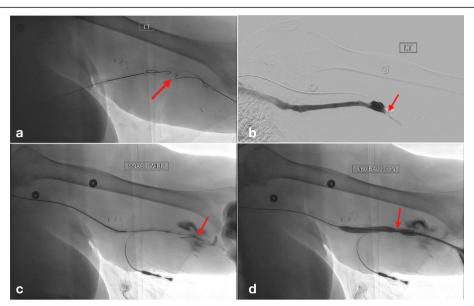
The micropuncture needles were exchanged over the 0.018" wires for micropuncture upsizing sheaths. Attempts were made to advance 0.035" glide wires (Terumo Corp; Tokyo, Japan) without success. The contrast was then injected from the antegrade and retrograde upsizing sheaths demonstrating access within the delaminated false lumen which showed a thin "tail" of contrast emptying into a widely patent native axillary vein.

Transfemoral access was then obtained via the left common femoral vein and an 8 Fr sheath was placed. A 5 Fr angled catheter was advanced over a glide wire (Terumo Corp; Tokyo, Japan) and was used to cross the graft vein anastomosis and gain access into the true lumen of the graft. A contrast injection demonstrated patency of the graft beyond the area of delamination without evidence of venous anastomosis stenosis (Fig. 2b).

A 3.2 Fr 4–8 mm En-Snare (Merit Medical; South Jordan, Utah) was advanced through the antegrade upsizing sheath and was used to capture the glide wire providing through and through access in the true lumen (Fig. 2c). The upsizing sheath was exchanged over the wire for a 7Fr sheath and balloon angioplasty of the graft was performed using an 8 mm Mustang angioplasty balloon (Boston Scientific, Marlborough, MA) showing a recurrent moderate to severe waist in the midportion of the graft (Fig. 2d).

Fig. 2 Failure to advance a 018" guidewire viz. local antegrade and retrograde accesses due to focal obstruction (arrow) in the midportion of the graft correlating with area of delamination seen on ultrasound (a). Transfermoral access used to selectively catheterize the left brachial vein and contrast injection confirmed position within the graft vein anastomosis (arrow) (b). Four to eight millimeters microsnare via antegrade micropuncture sheath used to externalize the glidewire from the arm creating a through and through wire access (arrow) (c). Persistent flow defect is seen in the mid-portion of the graft (arrow) after Balloon angioplasty and platelet plug embolectomy of the graft-artery anastomosis demonstrating the area of delamination which needs to be grafted (d)

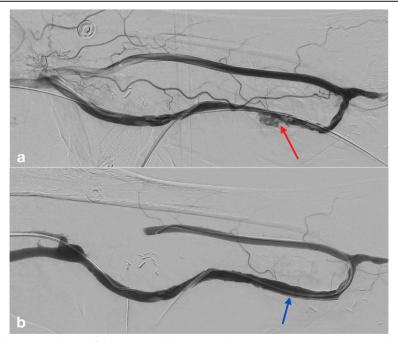
Fig. 3 Focal irregularity (red arrow) at the site of delamination, did not expand to suggest true extravasation (**a**) Final angiogram after placement of covered stent graft (Viabahn Endoprosthesis) (blue arrow) across the site of delamination showing correction of the focal irregularity and improved flow across the fistula (**b**)

Under ultrasound guidance, the graft's true lumen was then re-accessed in a retrograde fashion and a 6 Fr sheath was placed. Balloon angioplasty and platelet plug embolectomy of the graft artery anastomosis was performed with a 5 mm Mustang angioplasty balloon (Boston Scientific, Marlborough, MA). A brachial arteriogram was then performed which showed restoration of arterial flow through the graft. A focal area of extra-luminal contrast was identified (Fig. 3a) correlating to the area of fabric delamination. Via the retrograde access, an 8 mm × 50 mm Gore Viabahn Endoprosthesis (Gore Medical; Newar, DE) was deployed across the area of delamination and post dilated with an 8 mm angioplasty balloon. A completion brachial arteriogram demonstrated brisk flow through the graft with the resolution of the previously seen area of delamination (Fig. 3b).

Manufacturer and User Facility Device Experience Database, but only two cases have been published to date, which reports endovascular management of this complication (Dai et al. 2020). In our case, there was no significant stenosis at the venous anastomosis, but there was presence of thrombus in the entirety of the graft, which was partially corrected with balloon angioplasty and balloon-assisted platelet plug embolectomy. Interestingly, there was a persistent defect in the midportion of the graft appearing distinct from the typical intra-graft concentric stenosis and intraluminal thrombus. This occurred due to the delamination of the graft which created a false lumen that was compressing the true lumen. To correct this delamination, after the failure of angioplasty, a Viabahn endoprosthesis was deployed to obtain normal, brisk flow through the graft.
